FLOOD PLAIN INFORMATION

QUINEBAUG RIVER - CADY BROOK

TOWN OF SOUTHBRIDGE, MASSACHUSETTS

PREPARED FOR THE TOWN OF SOUTHBRIDGE BY THE DEPT. OF THE ARMY, NEW ENGLAND DIV., CORPS OF ENGINEERS, WALTHAM, MASS.

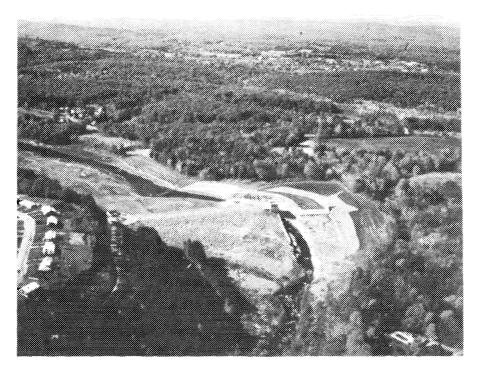
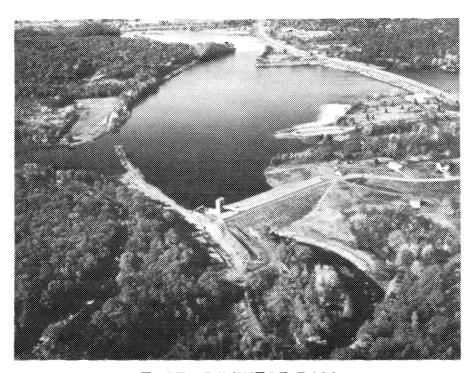
Figure 2

WESTVILLE DAM

EAST BRIMFIELD DAM
FLOOD CONTROL DAMS

Flood control dams in East Brimfield and Westville have been constructed by the Corps of Engineers on the Quinebaug River upstream of the town of Southbridge (See Figure 2). East Brimfield Dam is located in the town of Sturbridge about one mile southwest of the village of Fiskdale. Construction of the project was initiated in 1958 and completed in June 1960 at a cost of \$7,020,000. The reservoir can store 30,000 acre-feet equivalent to 8.3 inches of runoff from the drainage area of 67.5 square miles. Westville Dam and Reservoir is located in the towns of

Southbridge and Sturbridge. Construction was started in 1960 and completed in 1962 at a cost of \$5,590,000. The reservoir is capable of storing 11,100 acre-feet of floodwaters. This is equivalent to 6.5 inches of runoff from the net drainage area of 32 square miles below East Brimfield Dam.

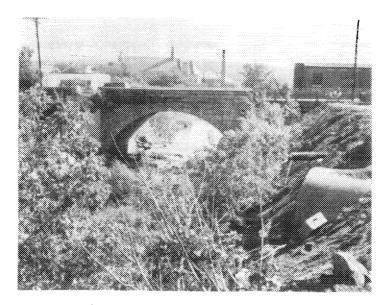
Figure 3

MECHANIC STREET BRIDGE

CENTRAL STREET BRIDGE
BRIDGES ACROSS QUINEBAUG RIVER

There are eleven bridges crossing the Quinebaug River in the reach covered by the report. Views of some of the bridges are shown in Figure 3. Table 3 lists pertinent elevations for the bridges and shows the relation to the Intermediate Regional Flood and the experienced August 1955 flood.

Inspection of the water surface profiles on the Quinebaug
River indicates that the bridges in general are not major restrictions to flood flows and no bridge will be inundated by the
Standard Project Flood. Dresser Hill Road Bridge will be an
obstacle to flood flows but will not be overtopped. Mechanic
Street Bridge will be an obstruction but will pass flood flows.
Approaches to the above bridges will not be inundated except
Mechanic Street Bridge, and that only when Cady Brook experiences
a flood with the magnitude of an Intermediate Regional Flood or
greater.

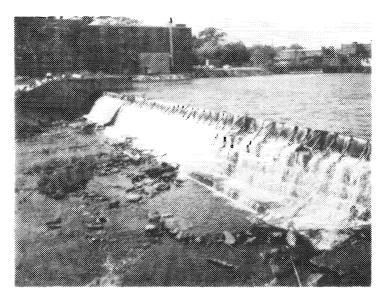
Figure 4

SANDERSDALE DAM

RUSSELL HARRINGTON DAM

DAMS ON QUINEBAUG RIVER

Views of two dams are on Figure 4. Sandersdale Dam at station

87+50. The American Optical Company Dam at station 112+00 and the Harrington Company Dam at station 190+50 were breached or damaged during the August 1955 flood. They were reconstructed and are now capable of passing flood flows.

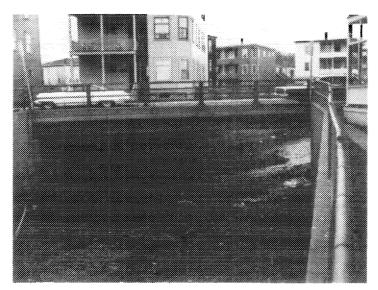
Figure 5

CHARLTON STREET BRIDGE

AMERICAN OPTICAL FOOTBRIDGE
BRIDGES ACROSS CADY BROOK

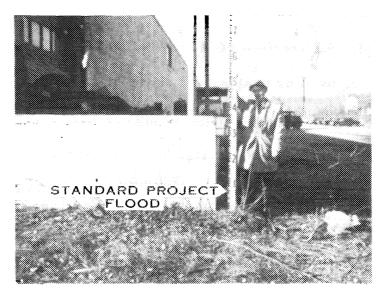
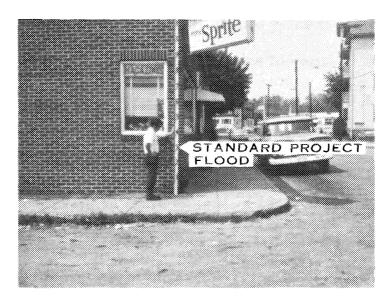
QUINEBAUG RIVER - Flood Height at Building below Dresser Hill Road Bridge

CADY BROOK - Flood Heights at Corner of Randolph and Green Streets

FLOOD HEIGHTS

Figure 6 shows the heights that would be reached by the Intermediate Regional and the Standard Project Floods on facilities presently existing within the flood plain in the vicinity of Southbridge.
